MI-COD

MSS INDIA- Case Of the Day

31 yr old woman (dancer);
c/o pain in the region of head of 1st metatarsal

MICOD case answer

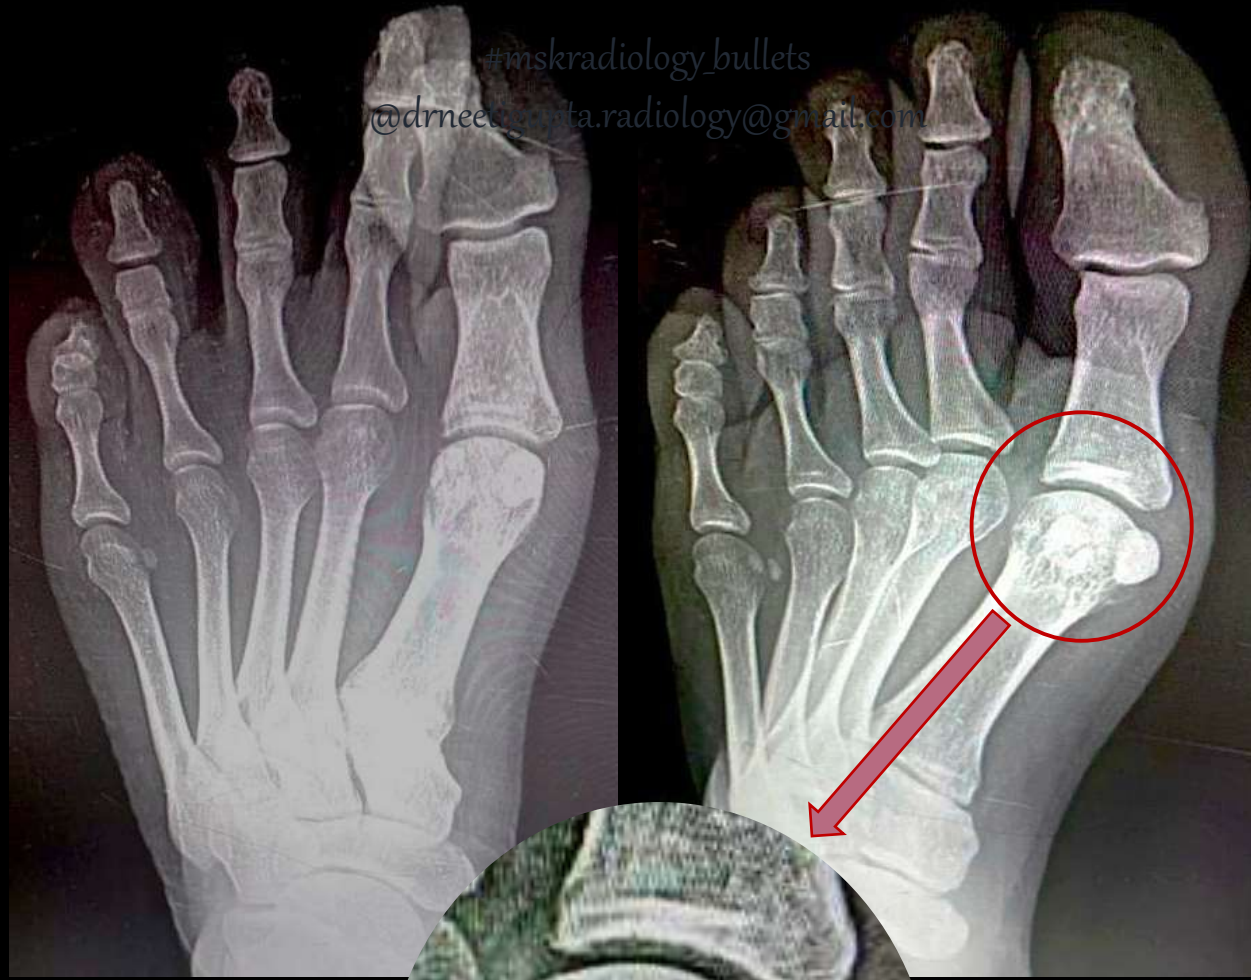
Lateral hallux
sesamoid fracture

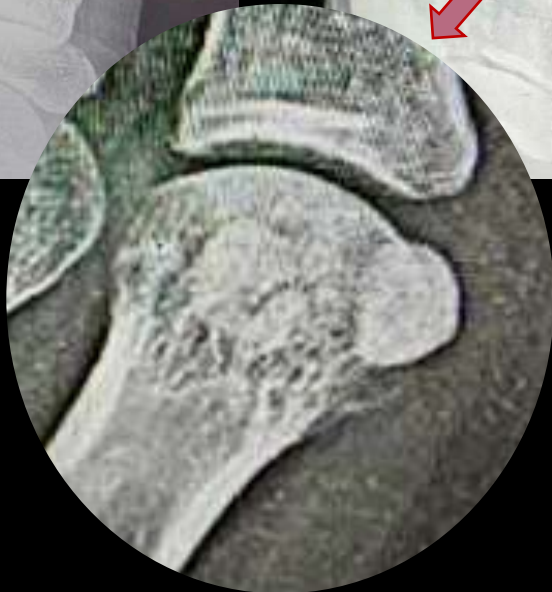
Lat.

Med.

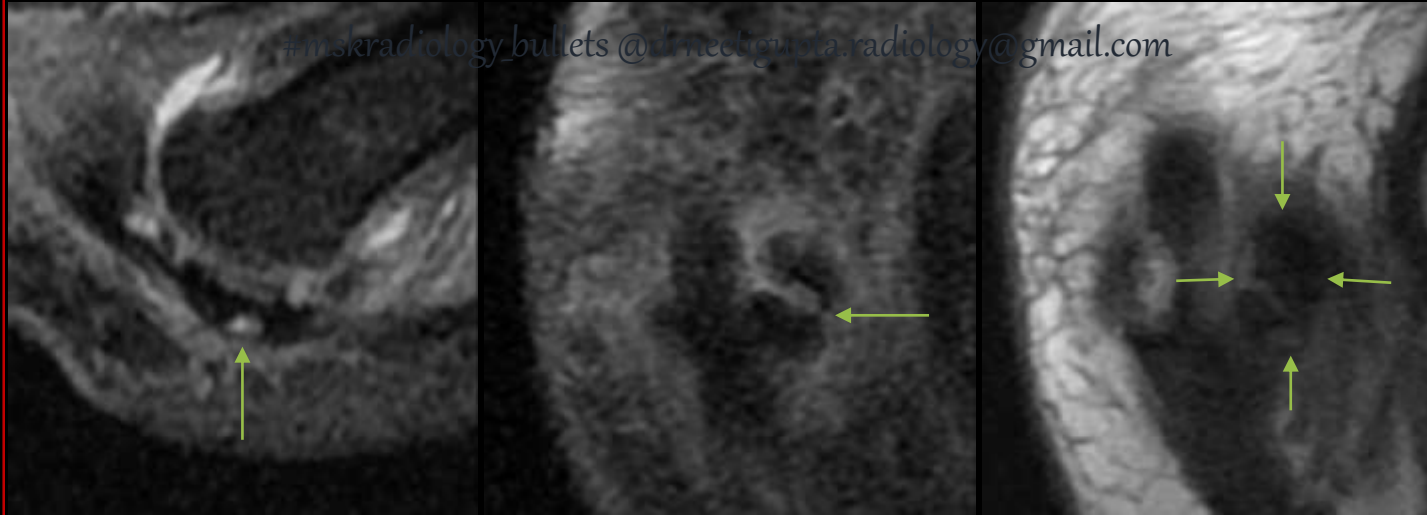
MRI was performed for further evaluation

Abnormal (hypointense) marrow signal and mild collapse of “lateral” hallux sesamoid bone - related to **sesamoid bone avascular necrosis**

Normal
“Medial” hallux
sesamoid
of same side
for comparison

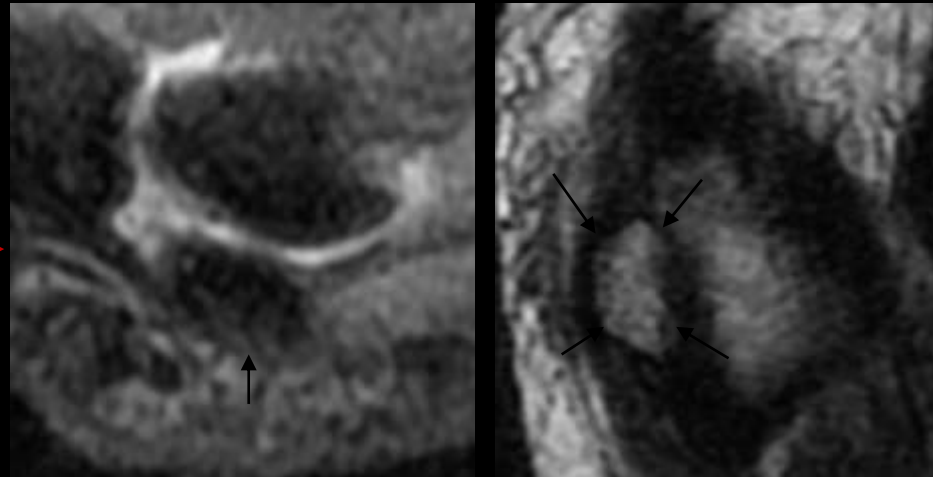
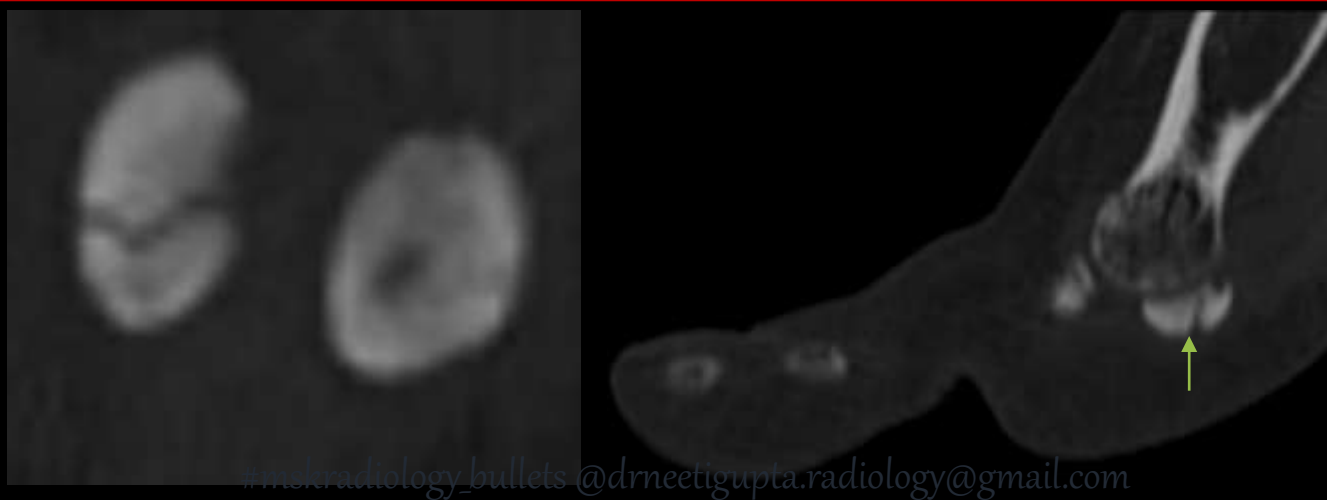
CT scan – lateral hallux sesamoid fracture with sclerosis, fragmentation and mild collapse in keeping with secondary avascular necrosis.

- AVN / Osteonecrosis may be caused by a # of the sesamoid bone
- It maybe difficult to differentiate between a bipartite sesamoid vs sesamoid fracture
- Faulty ossification leads to a multipartite sesamoid bone in up to 30% of individuals.
- Although either sesamoid can be affected, lateral sesamoid is subjected to greater loads, therefore, more prone to AVN
- **D/Ds** : infections; injuries with fractures; gout and other crystal deposition diseases; inflammatory arthritides; sesamoiditis dislocation; sesamoid osteoarthritis
- **Treatment** – elimination of weight bearing
