MICOD – 24/04/2024

MSS INDIA- Case Of the Day

Rapidly destructive arthrosis of shoulder

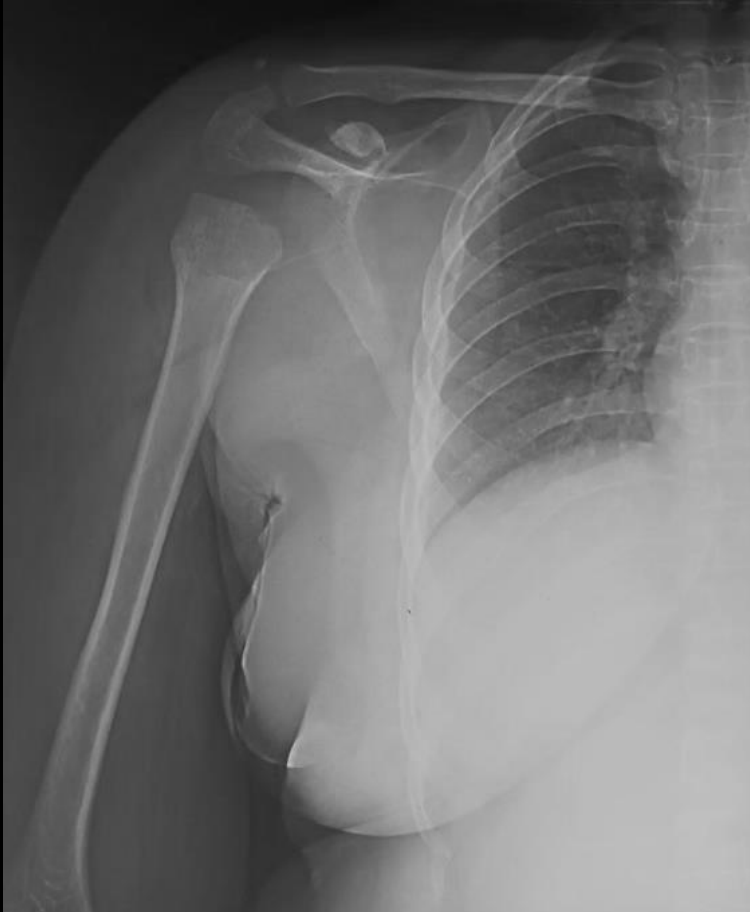
37-year-old lady with insidious pain in shoulder since 2 years. Took ATT in rural hospital “ as per the dictum “ TB in india can present like anything”

- RDA in shoulder is a *rare* event, characterized by rapid collapse of the humeral head with no evidence of other nonseptic articular arthropathy & presents a diagnostic challenge.
- Postel and Kerboull defined *rapid destruction as >2 mm in 1 year or 50% joint space narrowing in 1 year.*
- A unique pattern of *humeral head flattening, which appeared like a clean surgical cut with bone debris around the humeral head.*
- MRI findings revealed significant joint effusion and bone marrow edema in the humeral head, *without involvement of the glenoid.*
- Pathologic findings showed both fragmentation and regeneration of bone matrix, representing fracture healing
