# MI-COD

MSS INDIA- Case Of the Day

# 25-year-old gentleman with alleged history of trauma to the ankle

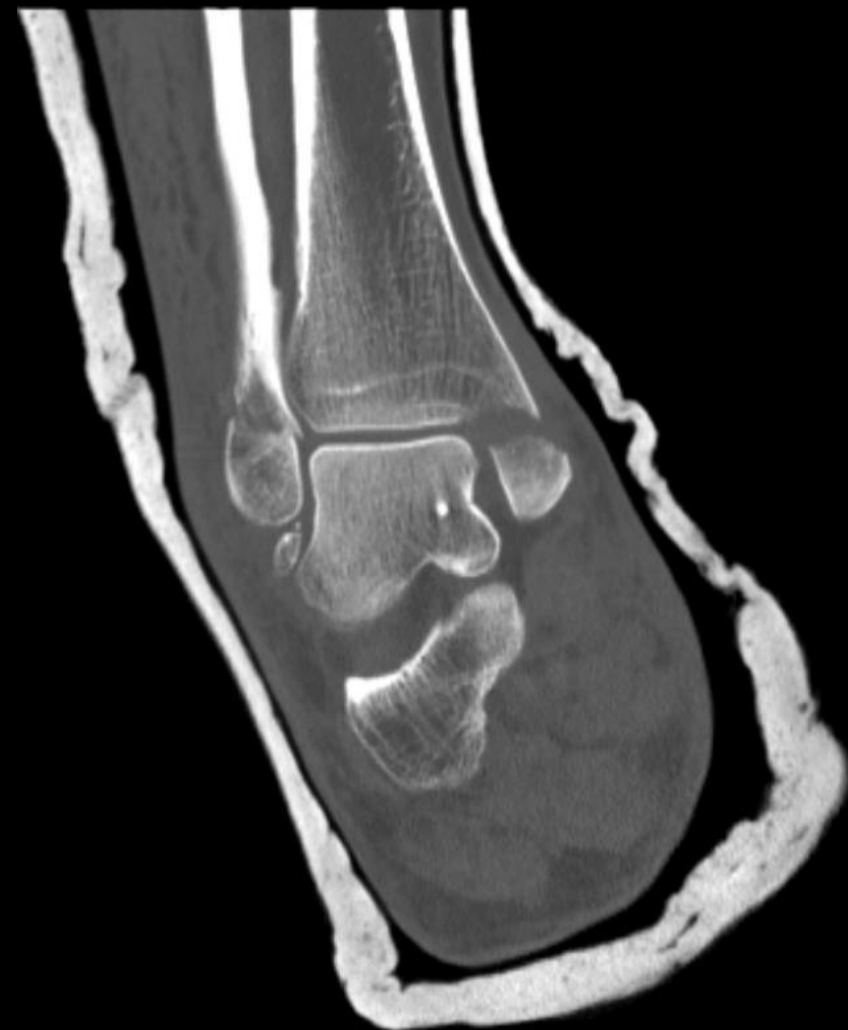
19:05 hours

CT after initial reduction  
Position satisfactory but they  
were unhappy about plaster  
Decision to change plaster

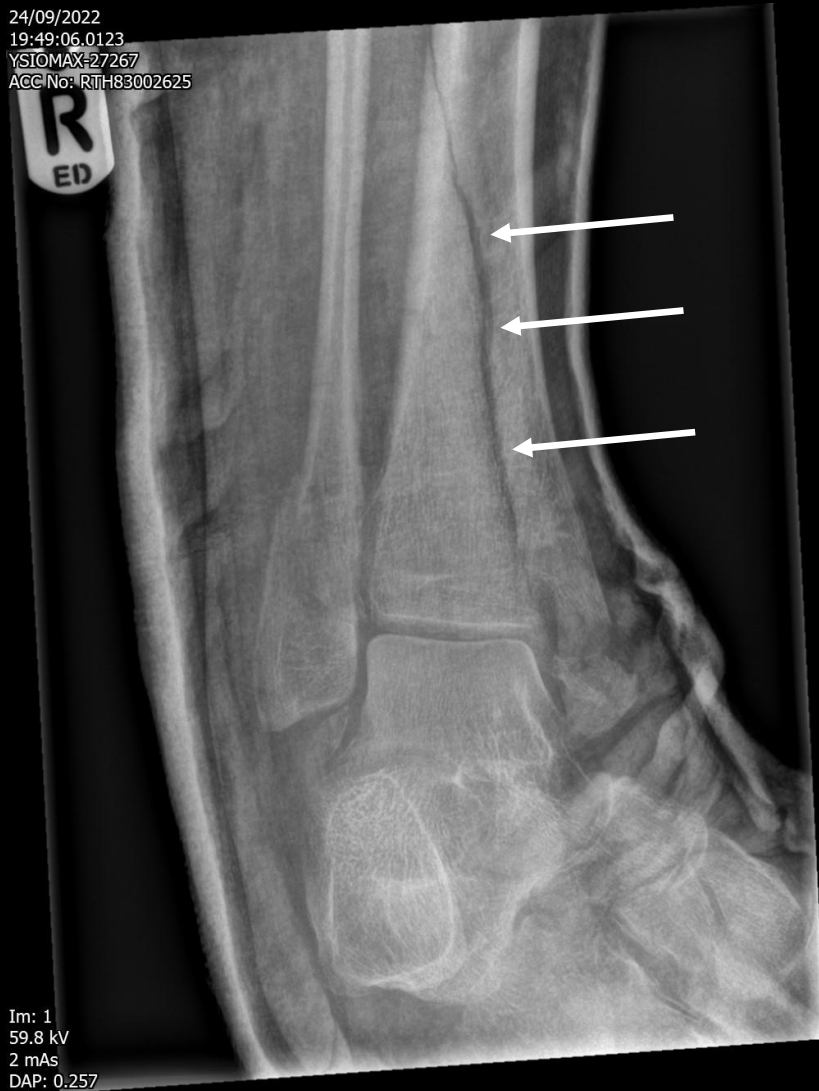
19:49 hours

- How can you explain the cause of that fracture seen in the second radiograph?
- What is the incidence of fractures secondary to reduction?
- What investigation should we perform next?

# Composition shadow from plaster, do nothing!

- In a young individual, the force required to cause a spiral fracture must be very high and almost impossible during manual fracture reduction. If still a fracture happens, the reducer must either be a wrestler or a kabaddi player!
- Secondly, there is already an unstable malleolar fracture, it is impossible to get the torque required to cause an adjacent fracture

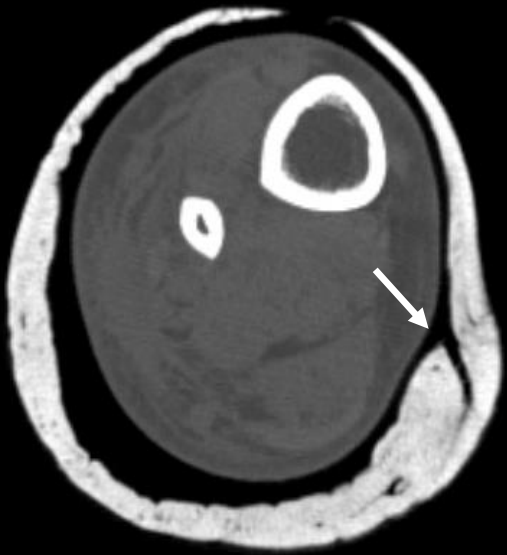
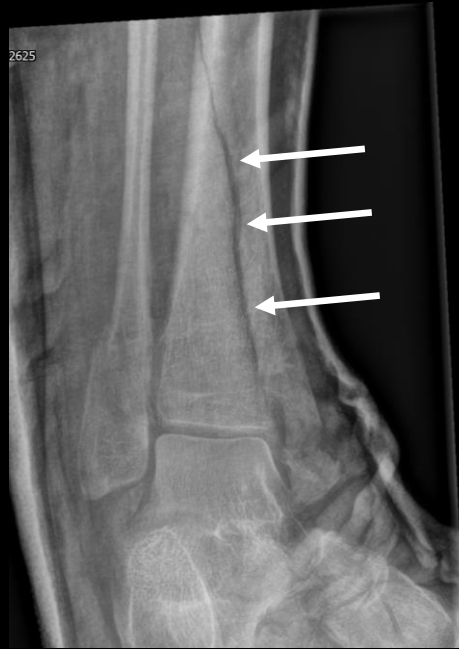
*Composition shadow from plaster*
